## MODERN PE PIPE ENABLES THE TRANSPORT OF HYDROGEN

### SHORT SUMMARY

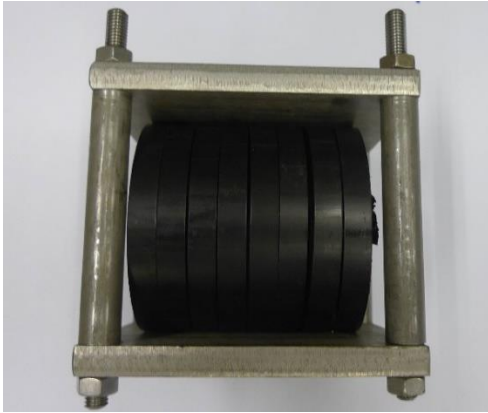
The deformation – and resulting stress – was applied to the rings by placing them in a U-clamp, which deformed the ring (see Figure 1 below). A strain of 1.9% was used for the DN90 SDR11 pipe. This initially corresponds to 50% of the upper yield strength, but this decreases over time.

Figure 1: PE rings in a U-clamp

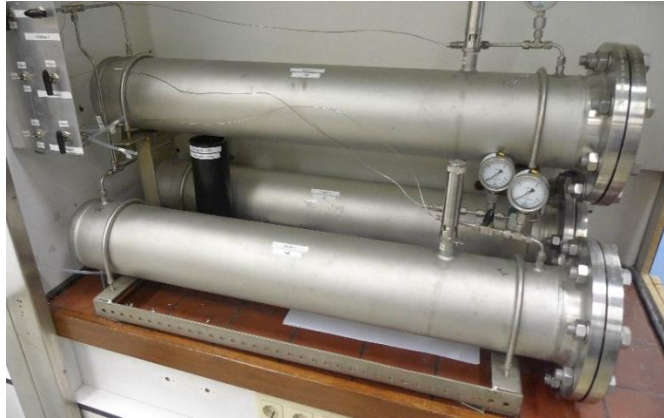
The U-clamps with the rings were placed in a cylinder at a pressure of 2 bar (see Figure 2 below) for a period of 1,000 hours at room temperature.

Figure 2: Cylinders filled with hydrogen at 2 bar

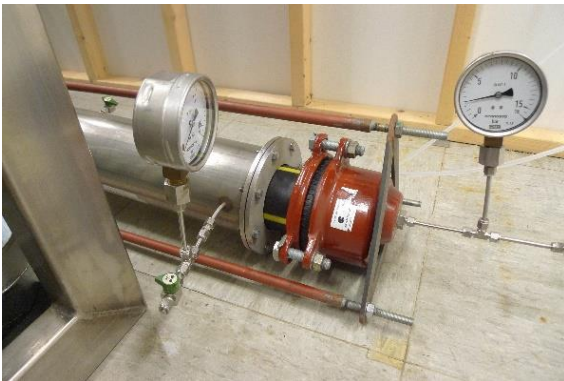
The tested PE pipe was sealed with end caps and placed inside a jacket pipe as shown in Figure 3. As the operational pressure in this case is 2 bar, the permeation test was performed with a overpressure of 2 bar (2 bar(o)) resulting in an absolute pressure of 3 bar (3 bar(a)) with respect to air. The jacket pipe was filled with 100% nitrogen.

Figure 3: Permeation experimental setup in which the PE pipe (black with yellow stripes), the jacket pipe (grey) and the pressure gauge are visible

The permeation rate was identified by measuring the concentration of hydrogen in the nitrogen in the jacket pipe using a gas chromatograph. Over time, the hydrogen will permeate the PE pipe wall and reach a steady state. The PC can then be calculated using this information.

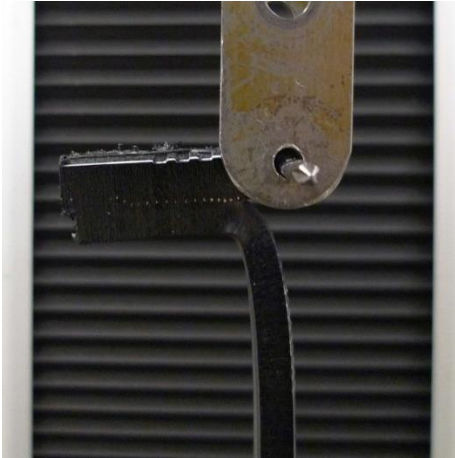
To examine the possible effects of hydrogen on the jointing of PE pipes, the joints were visually examined and tested using the peel test in accordance with ISO 13954 [3] (see Figure 4 and Figure 5).

Figure 4: Execution of the peel test

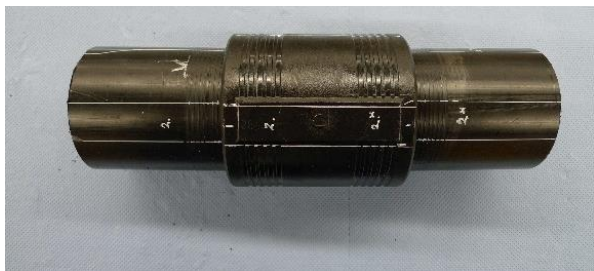
The visual test was carried out to reveal any cavities in the jointed surface. In the peel test, four bars from the electrofusion joint were taken from each side of the joints (see Figure 6 and Figure 7 below).

Figure 6: The electrofusion joint with the position of a tensile bar

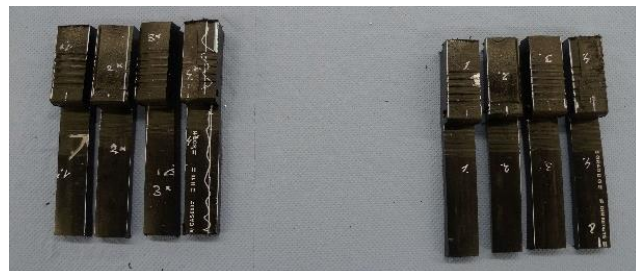
Figure 7: The tensile bars from both sides of the electrofusion joint

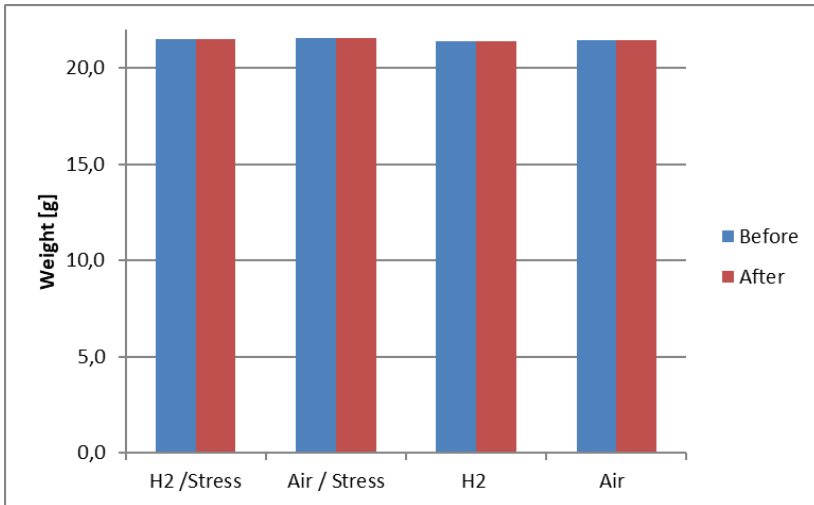
Figure 8: Outcomes of the weighing of the PE rings exposed to hydrogen or air with (8 rings) and without (6 rings) an applied stress

As can be seen in the graph and the table below (Table 1), the differences in weight are minimal. In none of the cases did the difference in weight exceed 0.1%.

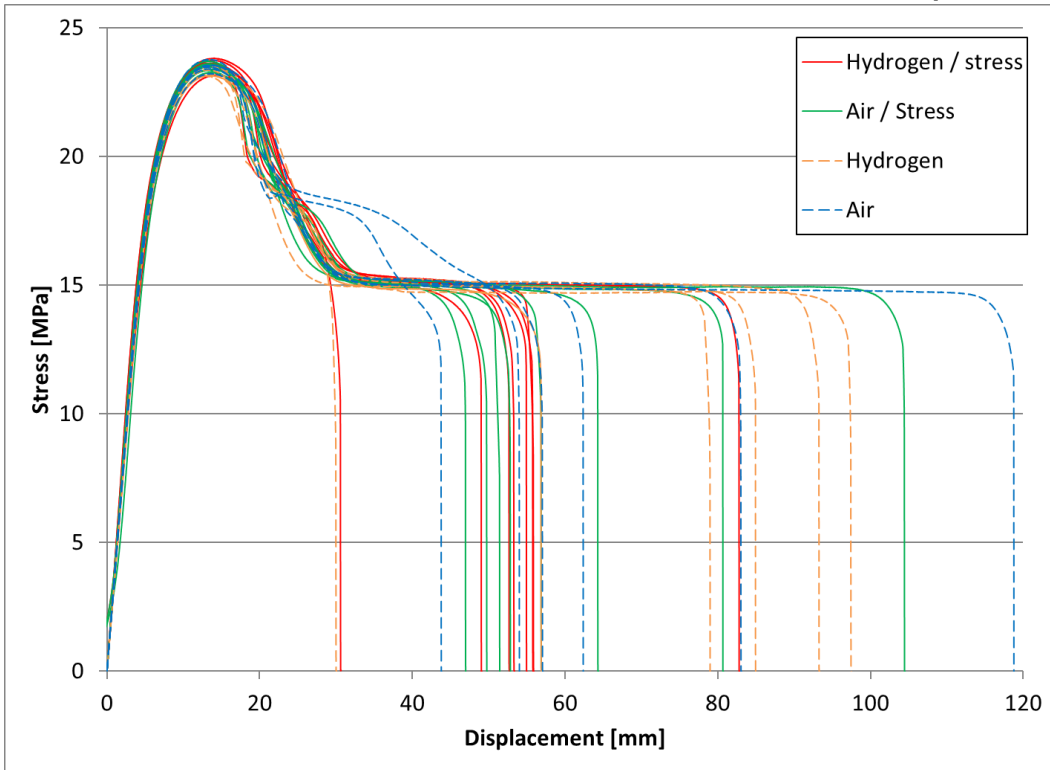
Figure 9: Ring tensile test. The horizontal axis shows the displacement [mm], the vertical axis shows the stress [MPa]. Red indicates hydrogen with applied stress, green indicates air with applied stress, orange indicates hydrogen without applied stress, and blue indicates air without applied stress.

For all tested rings, the upper yield stress lay within 1 MPa. This indicates that hydrogen has no negative effect on the PE material. The average values are summarized in the table below (Table 2).

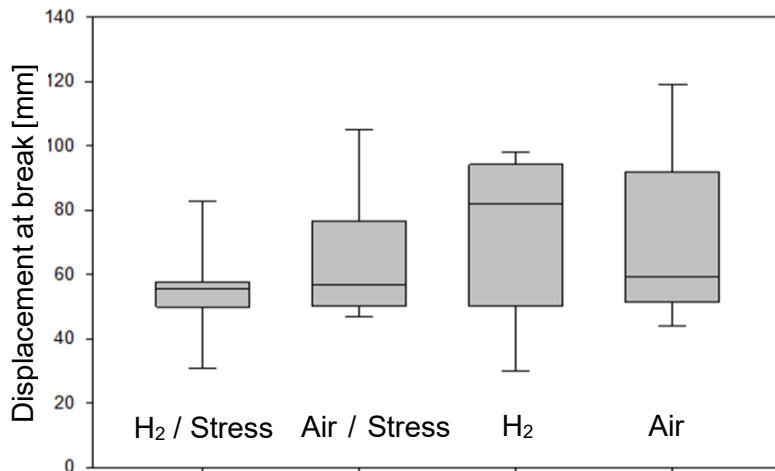
Figure 10: Whisker plot of the displacement at break. The measured extremes and median are given in the plot, while the other measured values are combined in the grey blocks.

As can be seen in the plot, there is a large spread in the measured values. However, the results are statistically comparable.

As can be seen in Figure 10, the spread and standard deviation are large for both the PE rings exposed to air and those exposed to hydrogen. This indicates that the environment, in this case hydrogen, is probably not the cause. This is also in line with the outcome of the weighing measurements and the measurements of the upper yield stress.

The spread in values for the elongation at break is probably caused by the test method. A further analysis of the results indicates two very low displacement values of 30 mm. Both of these rings were exposed to hydrogen, one with stress and one without stress. Analyses of the rings revealed an atypical failure type, in which the ring had yielded and broken on one side. All the other rings failed with yielding on both sides and a break on one side. It is probable that these two rings failed differently as a result of ring displacement during the test.

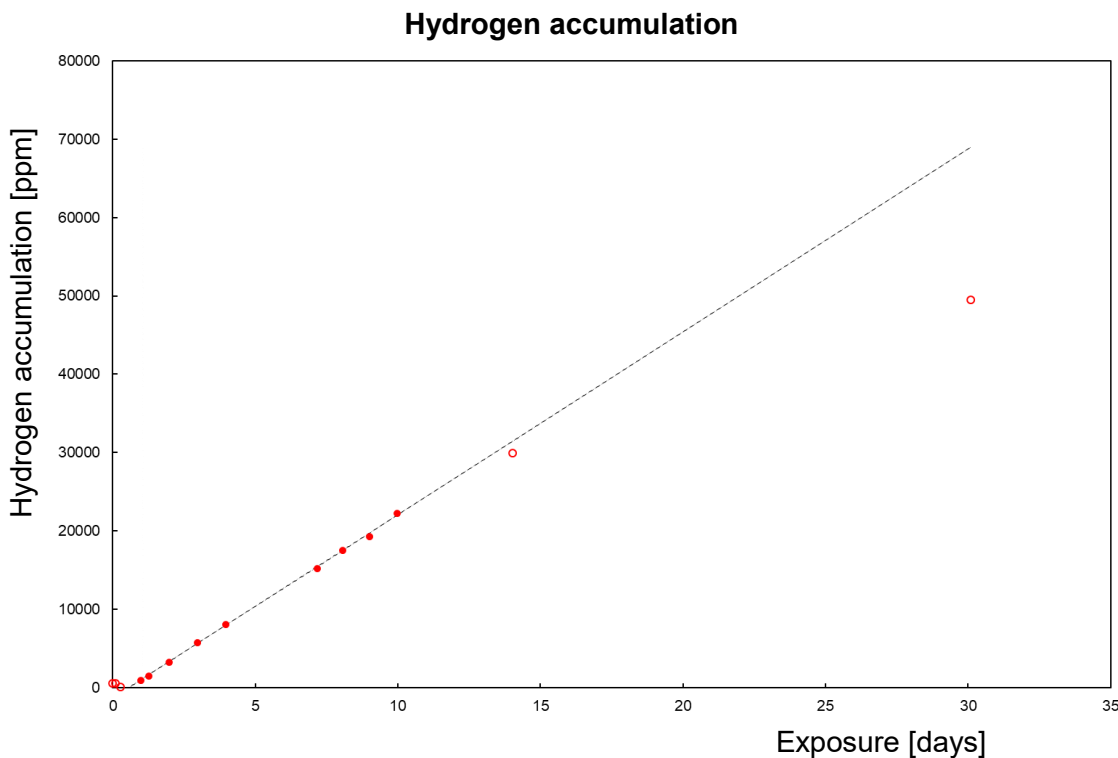
The permeation behavior of one of the pipes is given in the figure below. The vertical axis shows the measured accumulation of the hydrogen in ppm (parts per million) in the jacket pipe. The horizontal axes indicates the time in days, with the measured values indicated with red filled and open marks. The dotted line is the linear regression curve for the red filled values (nine values in total). The open marks were not used to calculate the regression, as the open marks in the lower timescale and the open marks in the higher timescale are indicative of non-linear behavior.

Figure 11: The horizontal axis indicates the exposure of the pipe to hydrogen in days, the vertical axis indicates the accumulation of hydrogen in the jacket pipe in ppm.

In the graph (Figure 11), it can be seen that the breakthrough time of the hydrogen is about one day. A steady state condition is then reached. The Permeation Coefficient (PC) can be calculated by using linear regression. Linear regression is performed using nine data points. The first three points are in

By using the PC, the permeated volume of hydrogen for the total length of the pipeline can be calculated if the length, pressure and SDR of the pipe are known. In this specific case, an SDR11 pipeline with a length of 1,000 meters, operated at a pressure of 2 bar, will emit 4,360 liters of hydrogen per year. This equates to 4.36 m<sup>3</sup> of hydrogen per year.

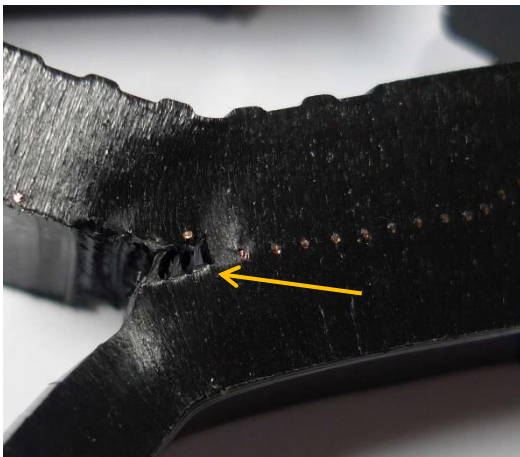
The electrofusion jointing procedure was followed without any noteworthy issues being encountered. No cavities were found in any of the test bars. The peel test also resulted in breakage of the pipes. No failure of the joint area was observed. The results are shown in the photographs below in Figure 12 and Figure 13.

Figure 12: The yellow arrow shows the ductile failure of the joint area

The permeation test demonstrated that the pipe wall is almost saturated with hydrogen after 1,000 hours. However, this did not result in visible voids or mechanical weak spots in the fusion zone. The temperature during jointing was higher than the melting temperature of PE. This probably led to depletion of the dissolved hydrogen during the jointing process.

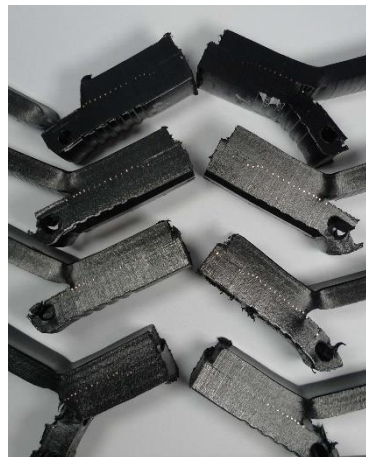
Figure 13: The visual examination showed no cavitation, which indicates a good quality joint
