## PLASSON ELECTROFUSION SADDLES: REDUCING DOWNTIME ON CRITICAL WATER INFRASTRUCTURE

Eungella Water Pipeline | Bowen Basin, QLD

### PLASSON ELECTROFUSION SADDLES: KEEPING A CRITICAL PIPELINE FLOWING

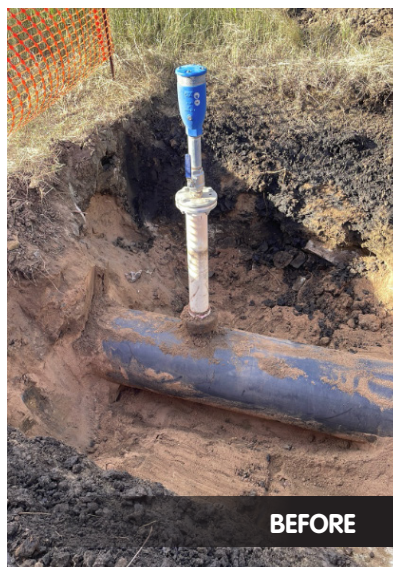
BEFORE

The Eungella Water Pipeline, a 123km critical water pipeline supplying Queensland's coal industry and the township of Moranbah, faced ongoing failures at several air valve connections. Conventional repair methods required extensive excavation, pipeline drain-downs and prolonged shutdowns, increasing costs and operational disruption. To address these challenges, A Queensland bulk water authority looked for a faster, more efficient repair solution that would reduce downtime, conserve water and extend the life of the pipeline.

The saddle repair needed a smaller excavation footprint than traditional pipe replacement, avoiding a full drain-down.

Plasson supplied an Electrofusion Repair Saddle and Electrofusion Branch Saddle, together with specialist tooling, installer training and on-site technical support for R & T Pumps.
