# THE PINES GOLF COURSE IRRIGATION UPGRADE

Pines Golf Course | Sanctuary Cove QLD

# CASE STUDY

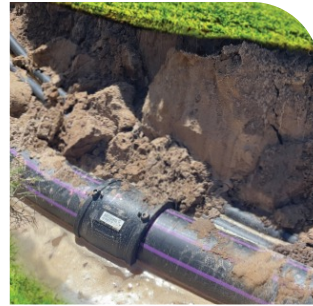
### TRUNK MAINS

PE pipes ranging from 125mm through to 315mm OD were joined by butt welding and electrofusion welding and installed by typical open trench outside the fairway.

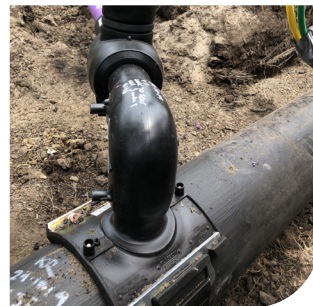
### CONNECTING TO LATERALS

Plasson electrofusion branch saddles were used to achieve smaller connections (63mm) from the large mains. The welded electrofusion branch saddles become homogenous with the pipe, making the joint stronger than the main pipe on its own.

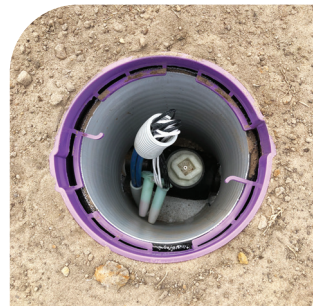
### ISOLATION VALVES

Plasson 63mm PE100 Ball Valves with PE spigot ends provided a fully welded solution up to and including the lateral isolation valves. The unique, fully injection-moulded one-piece design eliminates internal cavities and trapped dirt, while riser activation allows for a smaller, round valve pit.

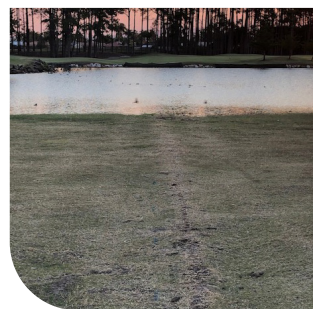
### LATERALS

A vibratory plough was used to install the 63mm PE through the fairways and around the greens. Metric compression fittings such as tees, elbows and tapping saddles were used to connect to sprinkler risers.

Vibratory plough was used to install the 63mm PE laterals. This reduced the number of joins and allowed a faster recovery time allowing play to resume in most cases within 2 weeks of installation starting.

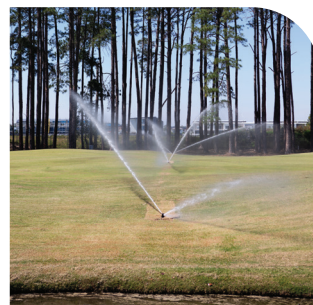
### SPRINKLER CONNECTIONS

Depending on the location of the sprinkler in relation to the 63mm lateral, either mechanical tapping saddle or 63x 1.1/4" metric female elbow fittings were used to connect the sprinkler articulated riser.
