PLASSON FITTINGS: THE PINES GOLF COURSE IRRIGATION UPGRADE

Pines Golf Course | Sanctuary Cove QLD

CASE STUDY

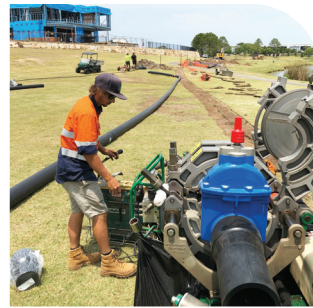
TRUNK MAINS

PE pipes ranging from 125mm through to 315mm OD were joined by butt welding and electrofusion welding and installed by typical open trench outside the fairway.

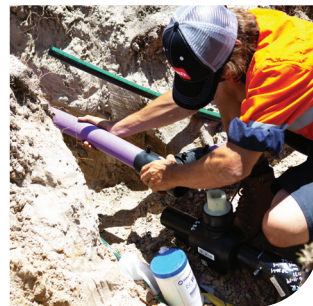
CONNECTING TO LATERALS

Plasson electrofusion branch saddles were used to achieve smaller connections (63mm) from the large mains. The welded electrofusion branch saddles become homogenous with the pipe, making the joint stronger than the main pipe on its own.

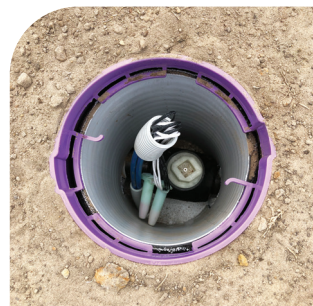
ISOLATION VALVES

Plasson 63mm PE100 Ball Valves with PE spigot ends provided a fully welded solution up to and including the lateral isolation valves. The unique, fully injection-moulded one-piece design eliminates internal cavities and trapped dirt, while riser activation allows for a smaller, round valve pit.

The monobloc design of the PE100 valves achieve a pressure rating of PN16, exceeding the system designed operating pressure of 750kpa.

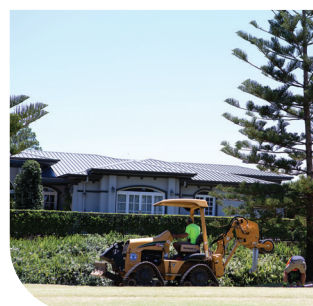
LATERALS

A vibratory plough was used to install the 63mm PE through the fairways and around the greens. Metric compression fittings such as tees, elbows and tapping saddles were used to connect to sprinkler risers.

A vibratory plough was used to install the 63mm PE through the fairways and around the greens, reducing the number of joints and allowing the course to be played within two weeks of installation.

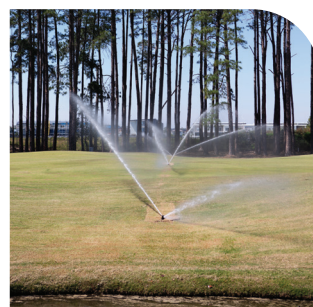
SPRINKLER CONNECTIONS

Depending on the location of the sprinkler in relation to the 63m lateral, either mechanical tapping saddle or 63x 1.1/4" metric female elbow fittings were used to connect the sprinkler articulated riser.
